Little Apple Cars

Automobile Status Report

2021 Nissan KICKS

VIN 3N1CP5BV1ML529970

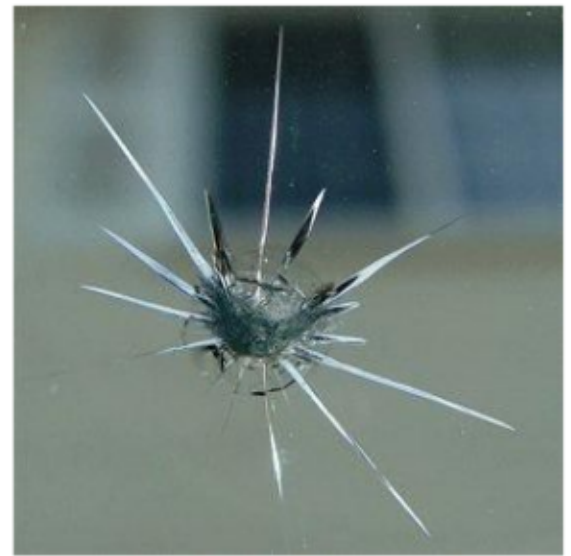
Windshield Chip Repair: Chip with small hairline crack in center of windshield. Several very small chips.

Every rock chip will eventually crack out, and it is hard to determine how long any chip can hold until

the damage is too large to repair, but if that little chip spreads, it will cost you a new windshield.

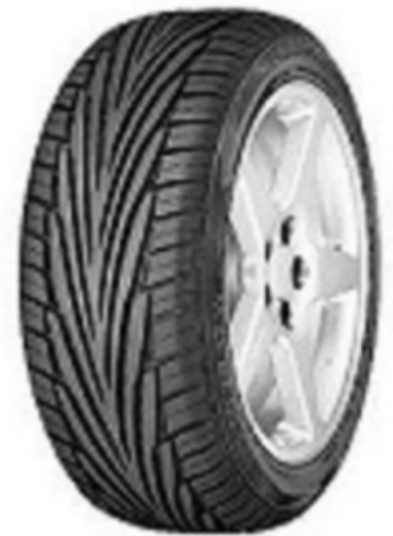
Tires

***Tires - 2: 205/60R16 - Front tires <5/32**

According to most states' laws, tires are legally worn out when they have worn down to $\frac{2}{32}$ " of remaining tread depth. As a tire wears it's important to realize that the tire's ability to perform in rain and snow will be reduced. With $\frac{2}{32}$ " of remaining tread depth, resistance to hydroplaning in the rain at highway speeds has been significantly reduced, and traction in snow has been virtually eliminated. If rain and wet roads are a concern, you should consider replacing your tires when they reach approximately $\frac{4}{32}$ " of remaining tread depth.

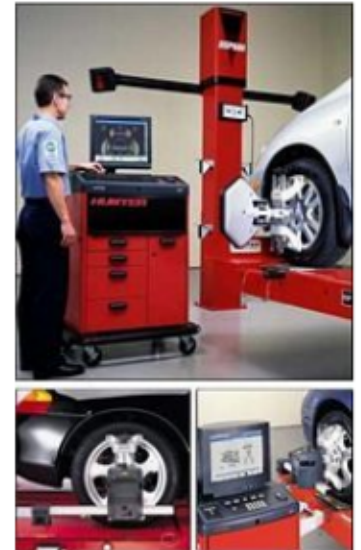
Alignment

***Alignment: Rear tires 8/32 with chopped wear on inside edges.**

If not done, you will see uneven or rapid tire wear, pulling or drifting away from a straight line, and wandering on a straight level road. It can also cause extra load on certain suspension components, making them more likely to fail.
