Automobile Status Report

2018 Jeep WRANGLER UNLIMITED JK

Multi-Point Inspection Checklist

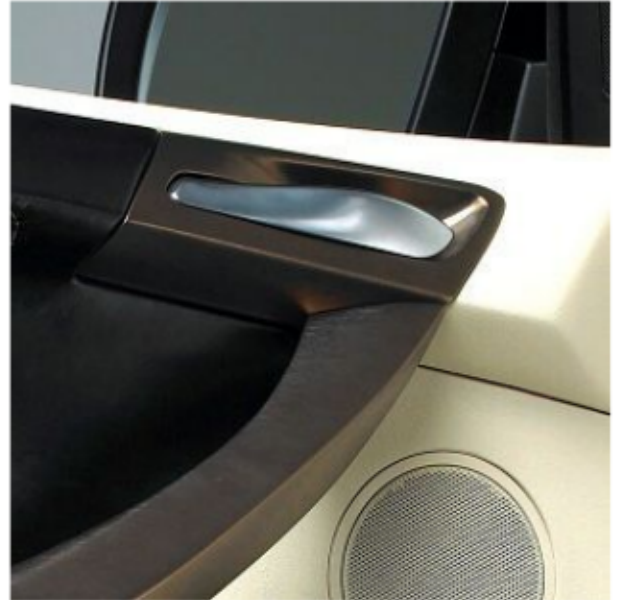
*Trim - Interior: AT Shifter Knob

Trim can crack and even break off. Damaged trim often looks unappealing and can even create sharp surfaces.

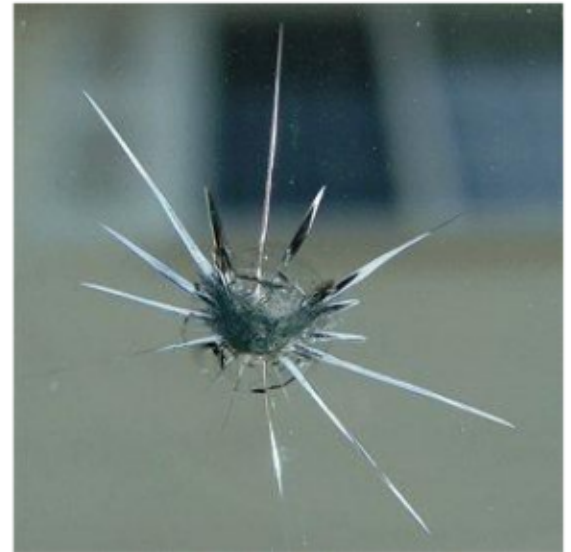
Windshield Chip Repair: In driver's view.

Every rock chip will eventually crack out, and it is hard to determine how long any chip can hold until the damage is too large to repair, but if that little chip spreads, it will cost you a new windshield.

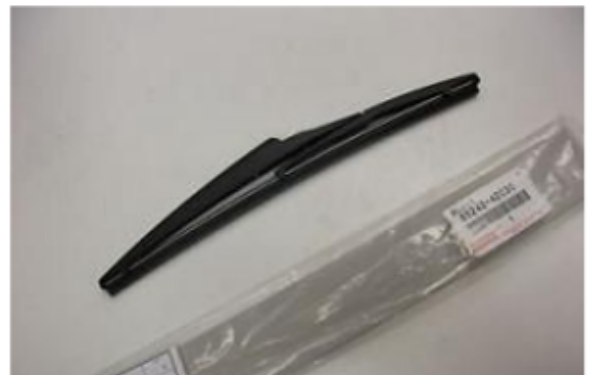
Wiper Blade Replacement - Rear

The rear windshield wiper will need to be replaced occasionally. When you notice the wiper streaking on the glass or becoming worn, remove it immediately and have it properly replaced.

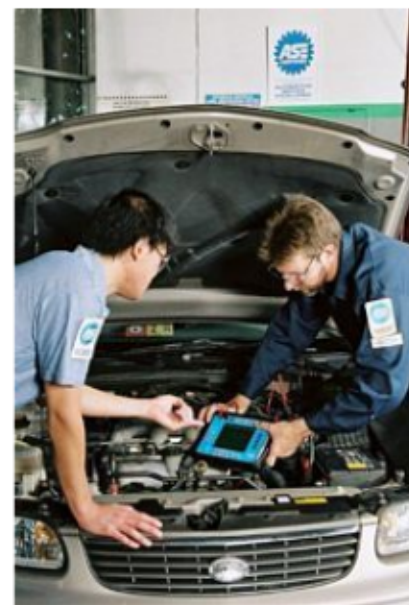
Diagnostic: TPMS light is flashing.

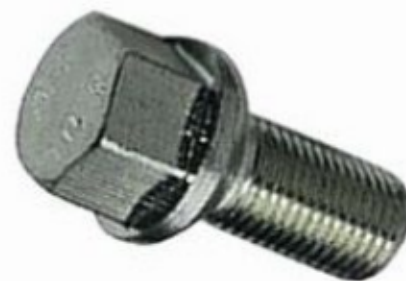
Wheel Fastener

Wheel Fastener: Five standard lug nuts. Has anti-theft lug nuts installed, one on spare also - have key.

If stripped, missing rusted or damaged in any way the wheel fasteners must be replaced. the wheel fasteners are the only objects holding your tire on your car. If left unfixed the wheel may become loose causing a major safety concern.

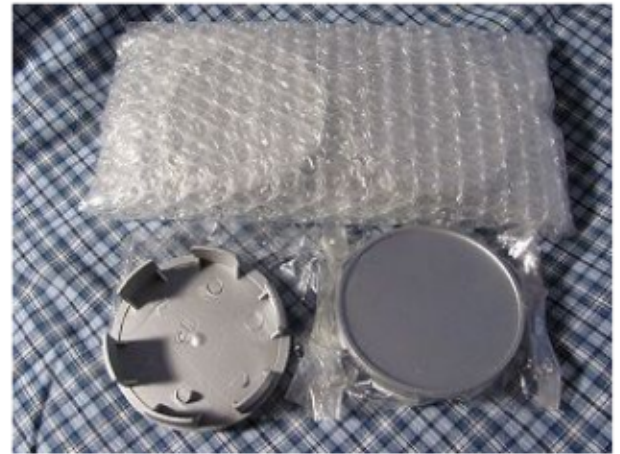
Wheel Center Cap: Right rear missing.

It also works as a dust cover and helps keep debris and dust from potentially entering the center hub behind the wheel.

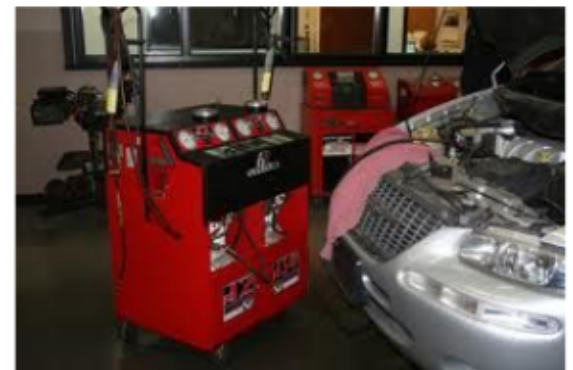
AC Recharge/Refresh

AC Recharge / Refresh: Poor A/C performance - hearing intermittent hiss from evaporator core indicating refrigerant level is low. Spec. 1.25 lbs. R-1234yf

A low charge will result in poor cooling under high heat loads due to a lack of reserve refrigerant. This can cause the clutch cycling switch of the compressor to click on and off.

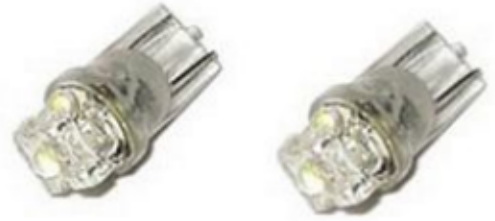
Side Marker Light

Bulb - Side Marker Replacement: Left front.

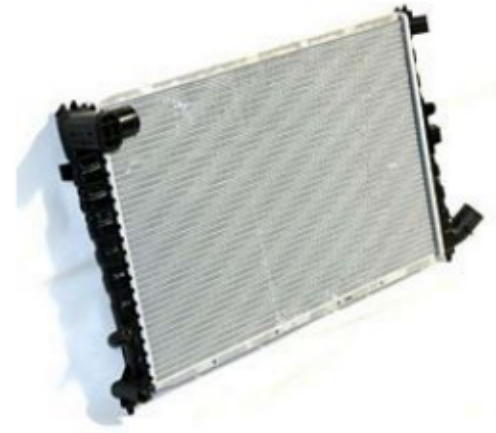
Radiator Replacement: Can see signs of radiator leaking from left tank - coolant residue up the seam. Not leaking during inspection.

If not replaced, a corroded and leaking radiator will cause the engine to overheat.

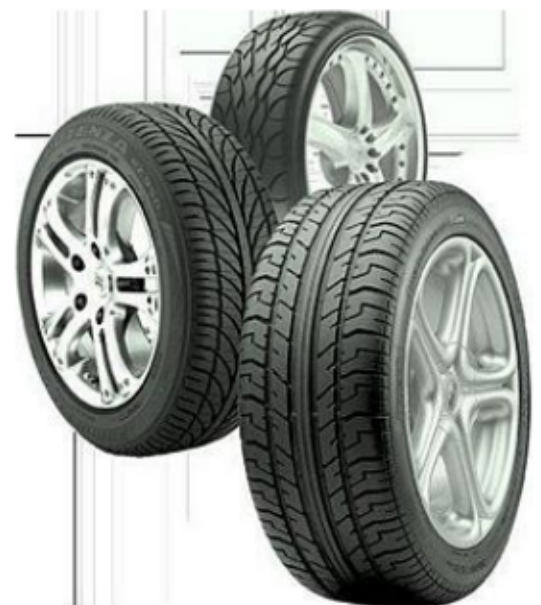
Tires

***Tires - 4: 255/70R18 - 4/32**

According to most states' laws, tires are legally worn out when they have worn down to 2/32" of remaining tread depth. As a tire wears it's important to realize that the tire's ability to perform

in rain and snow will be reduced. With 2/32" of remaining tread depth, resistance to hydroplaning in the rain at highway speeds has been significantly reduced, and traction in snow has been virtually eliminated. If rain and wet roads are a concern, you should consider replacing your tires when they reach approximately 4/32" of remaining tread depth.

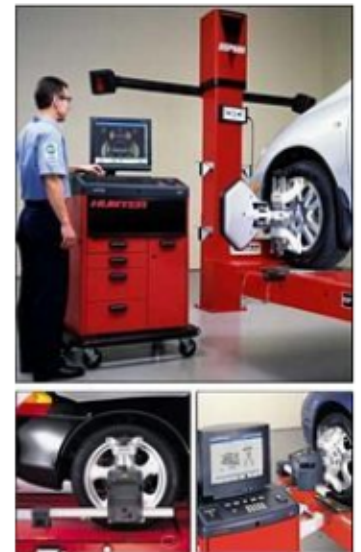
Alignment

*Alignment

If not done, you will see uneven or rapid tire wear, pulling or drifting away from a straight line, and wandering on a straight level road. It can also cause extra load on certain suspension components, making them more likely to fail.

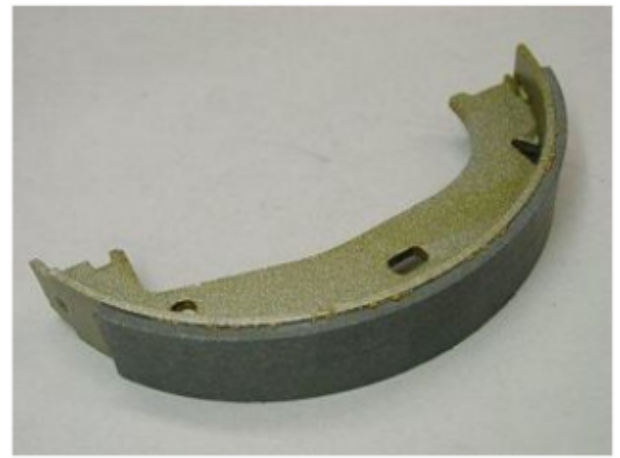
Emergency Brake Shoes: And Hardware Kit, Shoe Levers: Right side is not releasing.

If not repaired, the drum brake can lose seal and or stability, causing the brake to function improperly or not function at all causing a serious safety hazard to the driver and passengers

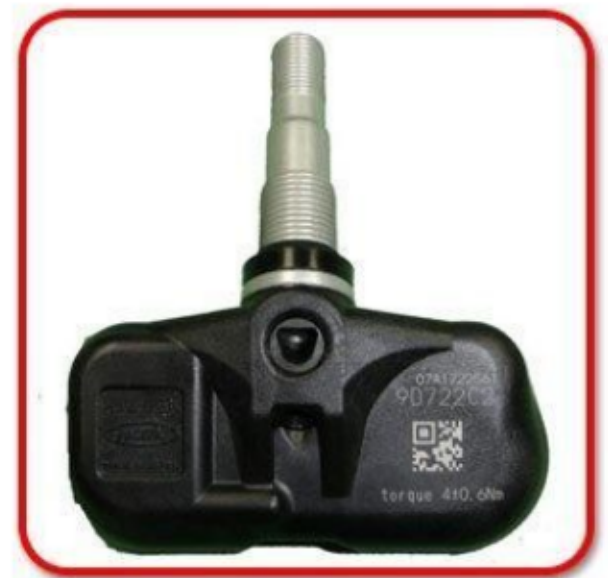
Tire Pressure Control Sensor: needs all 4 tpms sensors has none

If not replaced, proper tire information cannot be transmitted to the control module, leading to low tire pressure. Low pressure increases a tire's rolling resistance and minimizes fuel economy. It increases abnormal tread wear, and also causes a tire to run hot increasing the risk of tire failure and blowout. An under-inflated tire can also break traction more easily, which can cause skidding during braking or hard cornering, or wheel spin when accelerating.
