Automobile Status Report

2012 Jeep WRANGLER

Multi-Point Inspection Form

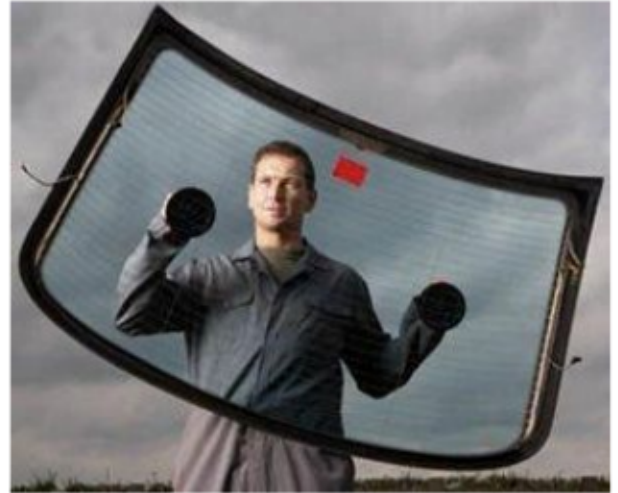
Windshield Replacement: Cracked

If not replaced, a damaged windshield not only puts the driver and passengers at risk but also the other vehicles on the road if the windshield breaks completely.

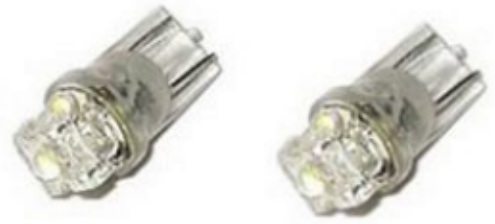
Side Marker Light

Bulb - Side Marker Replacement: Both front side marker lights out.

An important added safety feature.

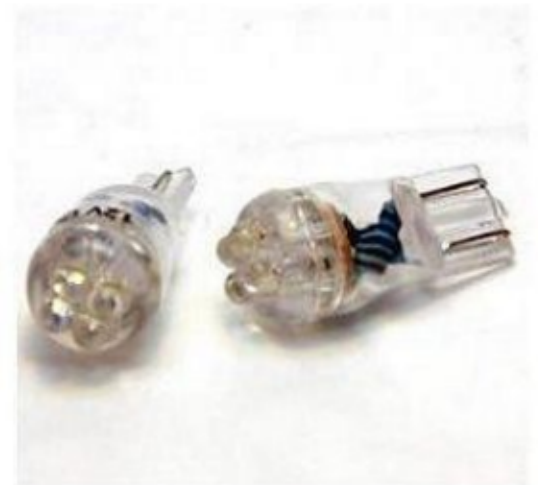
Bulb - License Plate Light

If not replaced, you will fail the vehicle inspection and could receive a ticket for improper equipment.

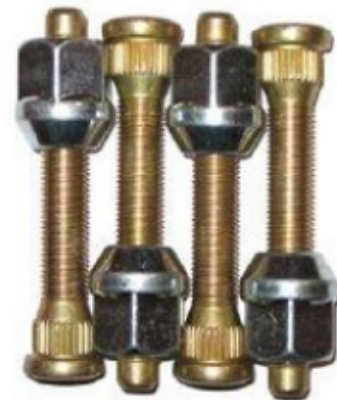
Lug and Wheel studs: One broken lug stud on right rear.

If not replaced, this creates a serious hazard to the driver and passengers. Without the lug and wheel studs functioning properly, the wheel will not be properly secured to the vehicle. If not addressed, eventually the wheel can separate, causing serious damage to the vehicle.

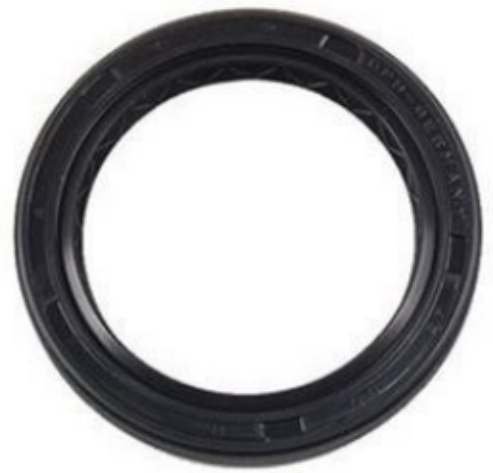
Axle Seal: Both sides of rear axle leaking (dripping onto wheels).

Possible contamination of E-brake shoes - not holding completely.

These seals must be maintained in order to ensure proper functionality of the vehicle's axles.

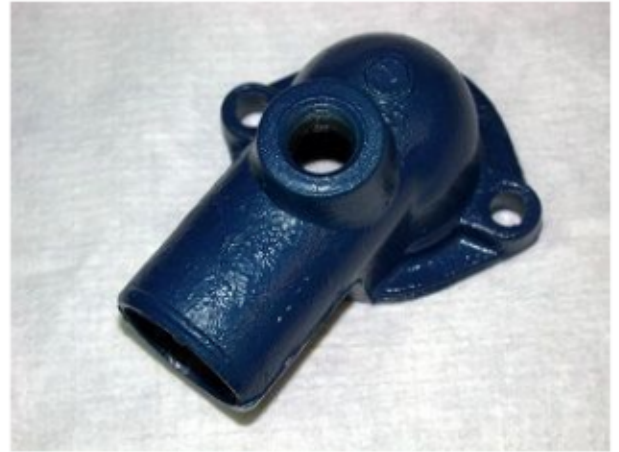
Thermostat Housing Replacement

If the thermostat housing becomes cracked or broken, it must be replaced in order to properly enclose the thermostat.
