Automobile Status Report

2016 Honda CR-V

VIN 5J6RM4H75GL139211

Multi-Point Inspection Checklist

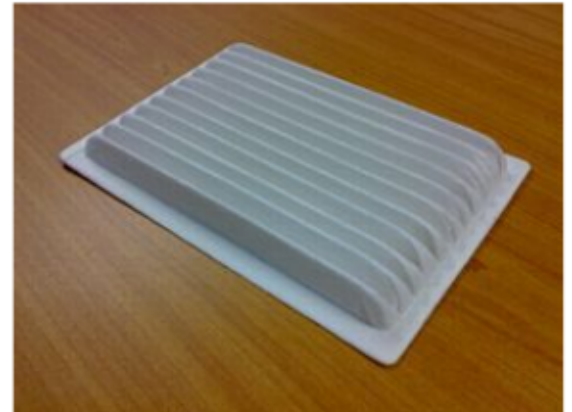
Cabin Air Filter Replacement

If not replaced, the air conditioning system will develop an odd odor. The air conditioning filter, also known as the cabin filter, removes dust and pollen from entering the car cabin.

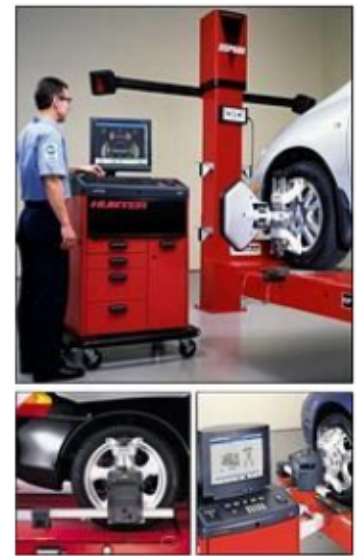
Alignment

***Alignment: Steering wheel is off-center to the left.**

If not done, you will see uneven or rapid tire wear, pulling or drifting away from a straight line, and wandering on a straight level road. It can also cause extra load on certain suspension components, making them more likely to fail.

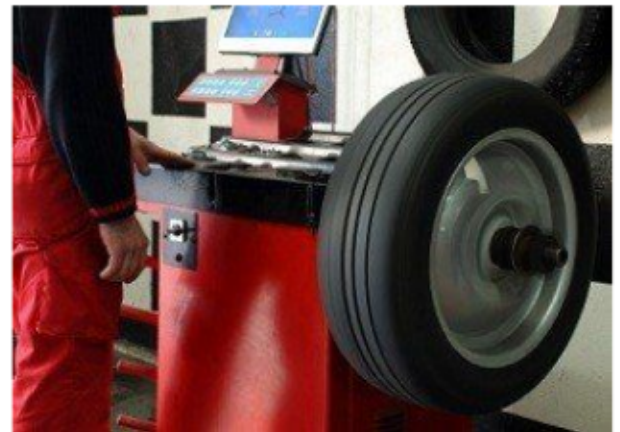
*Tire Balance and Rotate: Front 6/32, Rear 9/32

If not properly balanced, a vehicle's tires can experience abnormal wear which can significantly decrease the life of the tire. If not done, you will experience vibration in the steering wheel at certain highway speeds. Also, vibration will occur in the seat or floorboard at certain highway speeds. Tire wear will become scalloped or cupped.

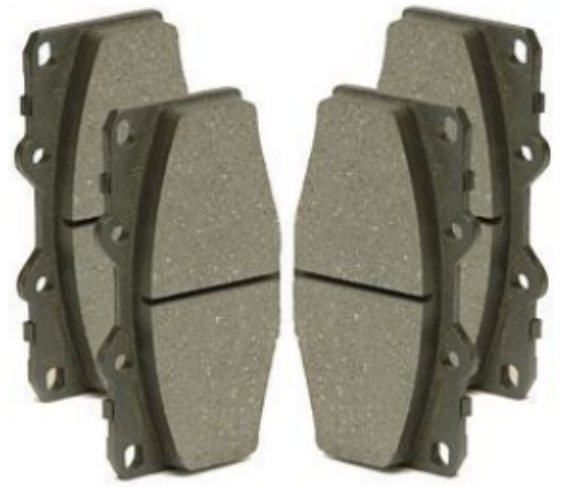
Brake Pads Replacement Only - Rear: 4mm

Brake pad material wears out over time. Brake pads should be periodically inspected for wear, which is highly variable depending on vehicle weight and driver habits. Brake pads must be replaced before the friction material is worn away completely. If it isn't, metal-to-metal contact will occur between the brake rotor and the worn-out brake pad. If metal-to-metal contact occurs, the brake rotor will be damaged, and it will need to be resurfaced or replaced.

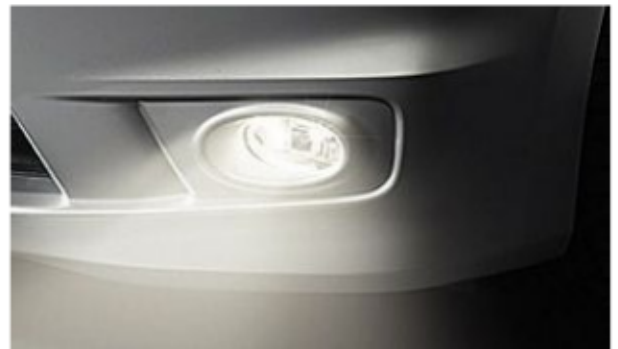
Bulb - Fog Light Assembly: Right fog light is out and there's a hole in the lens.

If not repaired, the fog lights will not function properly and the driver will lose the ability keep optimal vision in driving conditions such as rain, fog, dust or snow.

Bulb - Fog Light Assembly: Right fog light is out and there's a hole in the lens. (I)					
LABOR	1.70 hours at \$165.00 per hour				\$280.50
PARTS	Qty	Description	Number	Price	Total
	1	FOGLIGHT, R. FR.	33900T1WA11	\$252.51	\$252.51
Parts and labor sub total					\$533.01
*Trim - Interior: Rear hatch pull handle - pieced broken out. (I)					
LABOR	0.20 hours at \$165.00 per hour				\$33.00
PARTS	Qty	Description	Number	Price	Total
	1	POCKET *NH167L*	84441T0AA21ZB	\$8.98	\$8.98
Parts and labor sub total					\$41.98
*Trim - Interior: Screw and cover in right rear door pull handle is missing. (I)					
LABOR	0.10 hours at \$0.00 per hour				\$0.00
PARTS	Qty	Description	Number	Price	Total
	1	CAP, R. *NH167L*	83506T0AA01ZA	\$18.50	\$18.50
	1	SCREW, TAP (4X16)	90101S03000	\$2.75	\$2.75
Parts and labor sub total					\$21.25

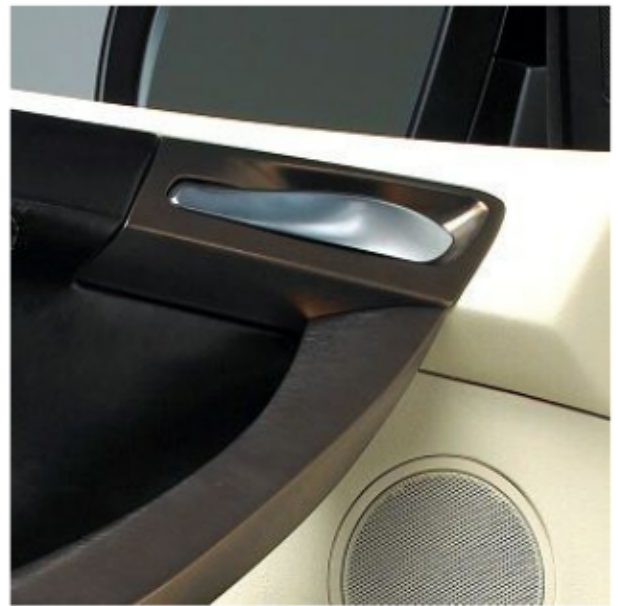
*Trim - Interior: Rear hatch pull handle - pieced broken out.

Trim can crack and even break off. Damaged trim often looks unappealing and can even create sharp surfaces.

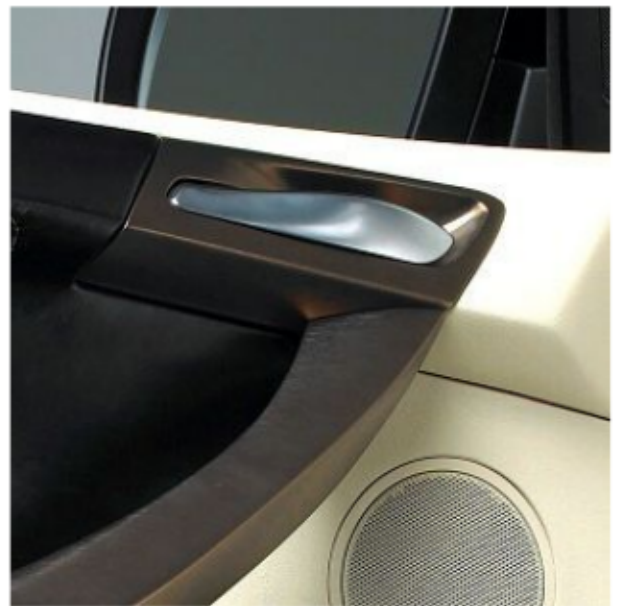
***Trim - Interior: Screw and cover in right rear door pull handle is missing.**

Trim can crack and even break off. Damaged trim often looks unappealing and can even create sharp surfaces.

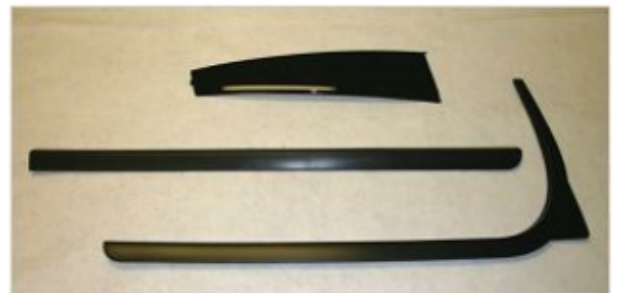
***Trim - Exterior: Rear wiper arm mounting nut cover is missing.**

Trim can crack and even break off. Damaged trim often looks unappealing and can even create sharp surfaces.

*Trim - Exterior: Rear wiper arm mounting nut cover is missing. (I)

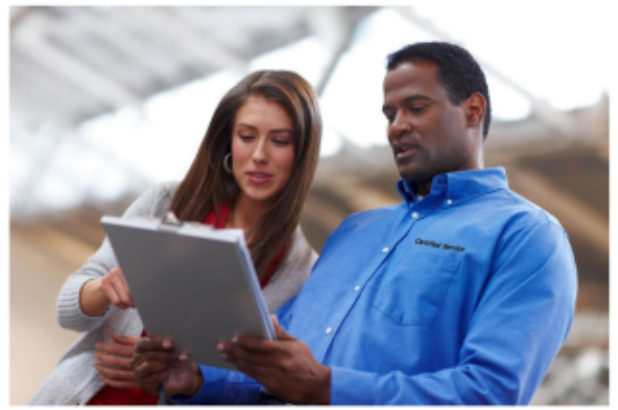
[Other]: car has a bad smell like something has died in vehicle need to try and find source of smell
