Little Apple Cars

Automobile Status Report

2017 Jeep PATRIOT

Multi-Point Inspection Form

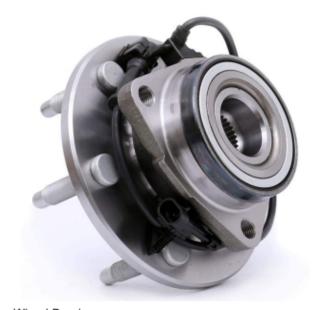
Front Wheel Bearing Replacement: Both - Equally noisy from both sides.

If not replaced, a failing front wheel bearing can cause a "rumbling" noise while turning and while driving at speeds greater than 15 miles an hour.
