Automobile Status Report

2021 Nissan VERSA

VIN 3N1CN8EVXML839442

Multi-Point Inspection Checklist

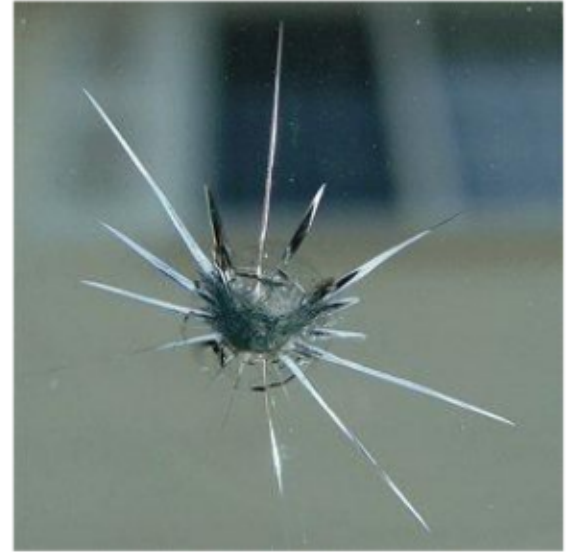
Windshield Chip Repair: Lower left

Windshield chip repair is a fast and convenient way to take care of the annoying but unavoidable rock chips.

Every rock chip will eventually crack out, and it is hard to determine how long any chip can hold until the damage is too large to repair, but if that little chip spreads, it will cost you a new windshield.

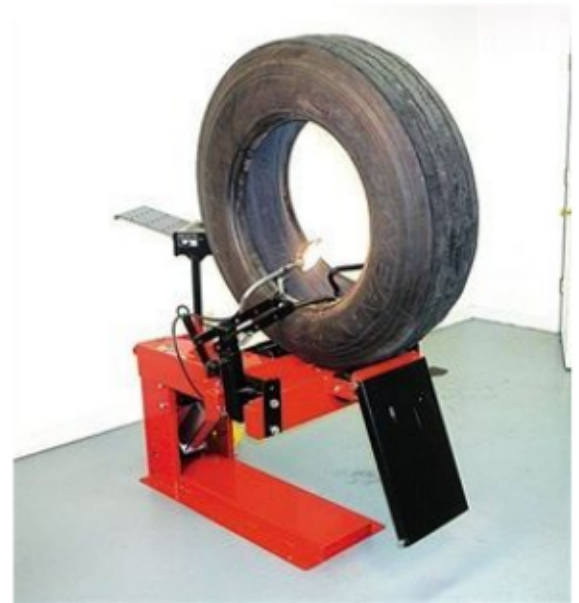
Tire Repair: Nail in left rear tire - repair-able? Close to edge of tread.

This is work necessary to fix a damaged or flat tire.

If not repaired, a damaged or flat tire will not ride properly due to deflation, puncture or other damage. This can prevent the vehicle from riding properly and comfortably.

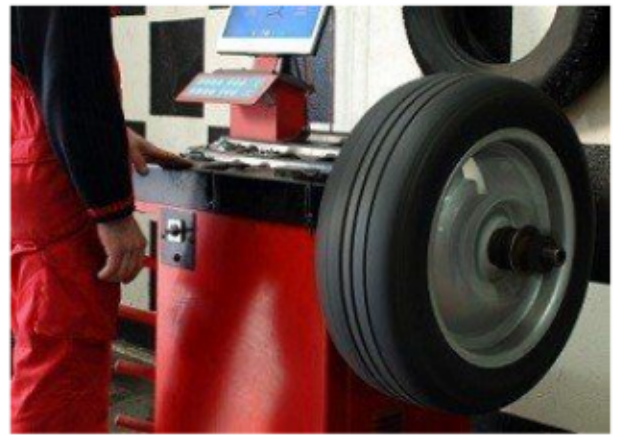
*Tire Balance and Rotate: Front 7/32, Rear 8/32 (Depend upon tire repair)

Balancing the vehicles tires are necessary to make sure the proper weight of the vehicle is distributed to the proper tire. Tire rotation helps protect tires against uneven wear by moving the tire location on the vehicle. Most tires will exhibit some form of

If not properly balanced, a vehicle's tires can experience abnormal wear which can significantly decrease the life of the tire. If not done, you will experience vibration in the steering wheel at certain highway speeds. Also, vibration will occur in the seat or floorboard at certain highway speeds. Tire wear will become scalloped or cupped.

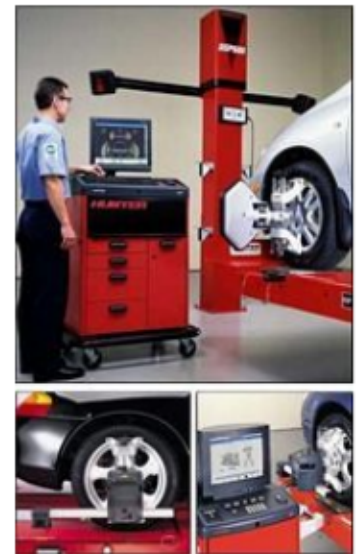
*Alignment: Tires showing inner edge wear.

Alignment is one of the key maintenance factors in getting the most wear and performance from your tires. In addition, wheel alignment provides safe, predictable vehicle control as well as a smooth and comfortable ride that's free of pulling or vibration. Today's modern suspensions require a precise four-wheel alignment that can only be achieved through a modern alignment system. This applies to both front and rear wheel drive vehicles. Aligning a car or truck involves the adjustment of the vehicle's suspension, not the tires and wheels. The direction and the angles that the tires point in after the alignment is complete, however, are critically important. There are four factors involved in setting the alignment to specification: caster, camber, toe and ride height.

If not done, you will see uneven or rapid tire wear, pulling or drifting away from a straight line, and wandering on a straight level road. It can also cause extra load on certain suspension components, making them more likely to fail.

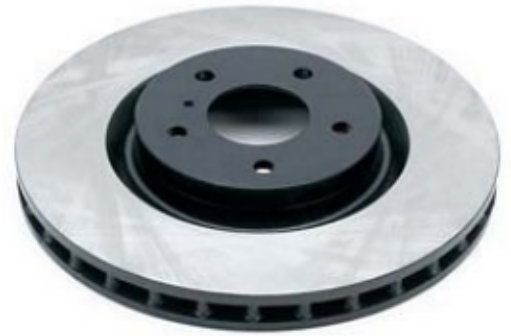
Brake Rotor Replacement - Front: Brake pulsation - Rust/hot spotted.

Brake rotors are the parts within the wheels of an automobile which brake pads squeeze in order to slow the rotation of the wheel and bring the vehicle to a stop.

When the pads are replaced, the rotor must be resurfaced smooth to allow the new pads to have an even contact surface to work with. Only a small amount of material can be machined off of a rotor before it becomes unusable and must be replaced. A minimum thickness measurement is stamped on every rotor and the technician doing the brake job will measure the rotor before and after machining it to make sure it doesn't go below the legal minimum. If a rotor is cut below the minimum, it will not be able to handle the high heat that brakes normally generate. This will cause the brakes to "fade," greatly reducing their effectiveness to a point where you may not be able to stop. At this point the brake rotor needs to be replaced.

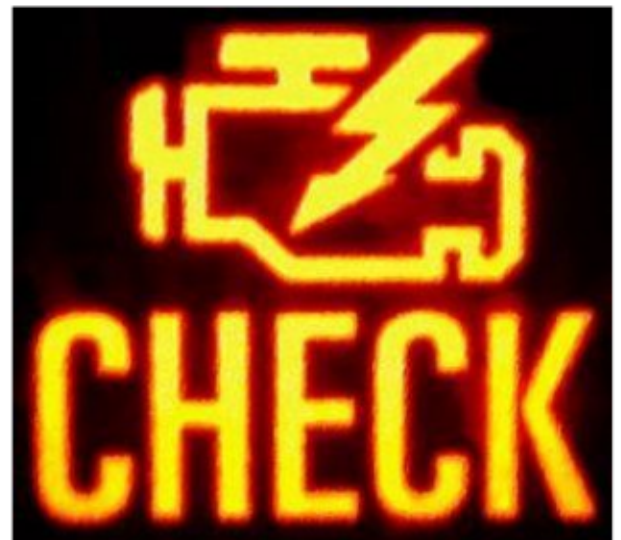
***Diagnostic - Check Engine Light:
DTC P0420 Catalytic Converter
Efficiency - History. Cleared DTC -
Monitor for return.**

When the vehicle's computer senses that there is a problem with some of the components it stores, the corresponding trouble code(s) in its memory light up the "Check Engine" or "Service Engine Soon" light, to tell you that there is a problem and your car needs to be looked at.

If not serviced when needed a small simple problem can turn in to a large hazardous issue.

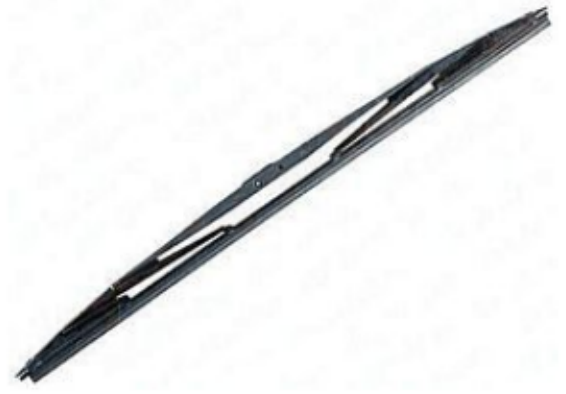
Windshield Wiper Blade

**Wiper Blade Replacement - Front:
front wipers are torn need to replace**

The wiper blade is a rubber blade attached to the

If not replaced, worn out wiper blades can cause restricted visibility and permanent damage to the windshield.
