# Automobile Status Report

2017 Ford MUSTANG

# Multi-Point Inspection Checklist

# Additional Service Recommendations

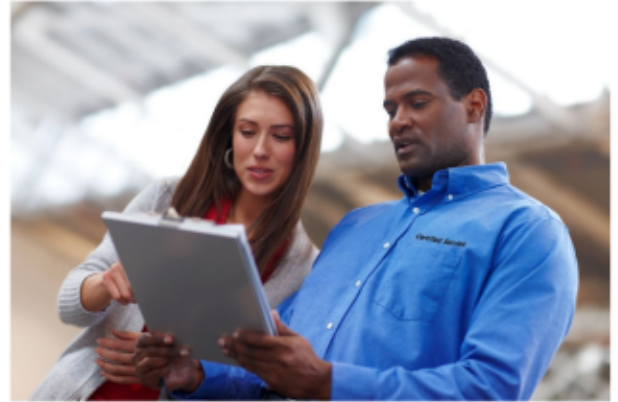
## [Other]: OEM Tire Mobility Kit - "Service Tire Mobility Kit" message. Kit missing.

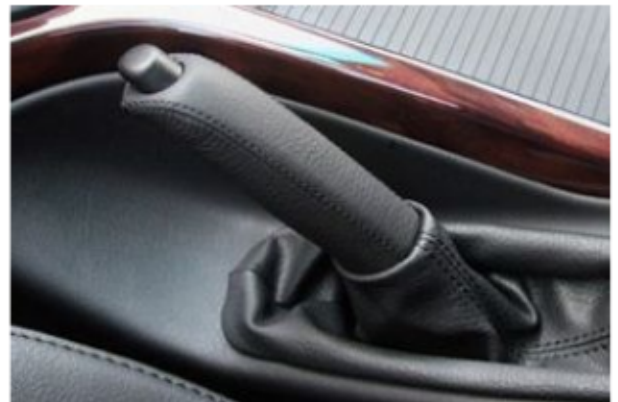
## Emergency Brake Adjustment: Not holding vehicle completely.

Not having a properly functioning emergency brake can be a safety hazard to the driver and passengers if the vehicle must be stopped abruptly. Emergency brake adjustment is needed for repair or maintenance to ensure proper functionality of the emergency brake.

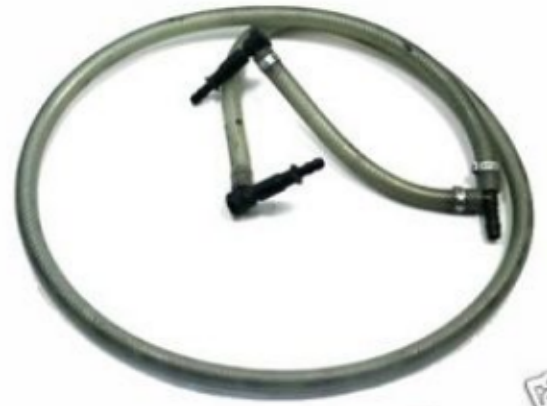
## Washer Fluid Hose: &/or Connector. Washer hose is apart at T-connector.

Leaking or clogged Washer Fluid Hoses can cause a lack in pressure or provide none at all. It is recommended that all hoses be free of debris and able to hold a tight seal to provide adequate pressure for the nozzles.

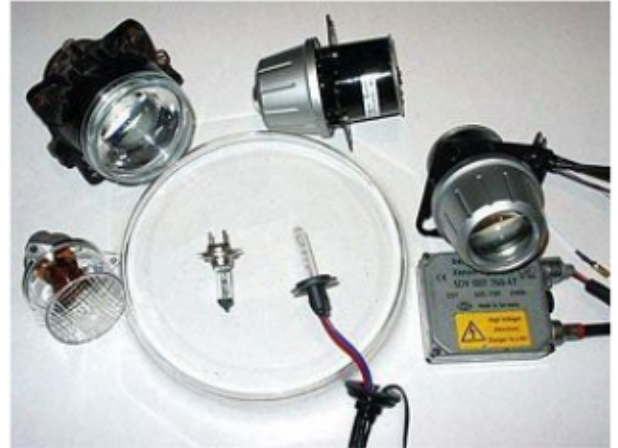
## Bulb - Park Lamp: Left outer front.

If not repaired, the park lamp will not illuminate when the turn signal is activated. This can pose a safety threat when operating the vehicle and in many states will prevent the vehicle from passing safety inspection if not functioning properly.

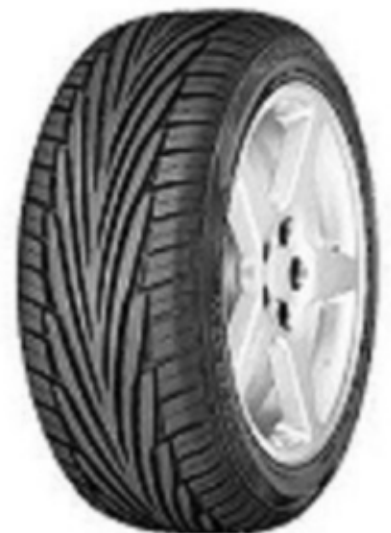
Tires

## \*Tires - 2: 275/40ZR19 - Rear tires 4/32.

According to most states' laws, tires are legally worn out when they have worn down to 2/32" of remaining tread depth. As a tire wears it's important to realize that the tire's ability to perform in rain and snow will be reduced. With 2/32" of

remaining tread depth, resistance to hydroplaning in the rain at highway speeds has been significantly reduced, and traction in snow has been virtually eliminated. If rain and wet roads are a concern, you should consider replacing your tires when they reach approximately 4/32" of remaining tread depth.

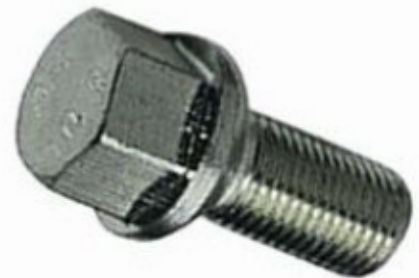
Wheel Fastener

## **Wheel Fastener: Qty 5 - Left rear has wrong wrench size lug nuts. Has 21mm, should be 7/8".**

If stripped, missing rusted or damaged in any way the wheel fasteners must be replaced. the wheel fasteners are the only objects holding your tire on your car. If left unfixed the wheel may become loose causing a major safety concern.

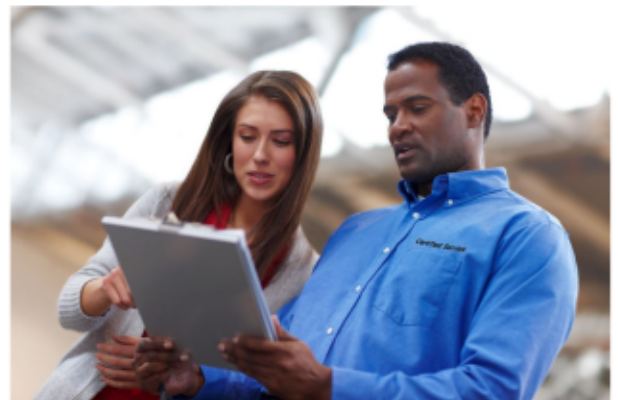
## **[Other]: Thread repair - upper licensed plate bolt holes are stripped out.**
