Automobile Status Report

2021 Audi Q5

VIN WA1BAAFY2M2017850

Multi-Point Inspection Checklist

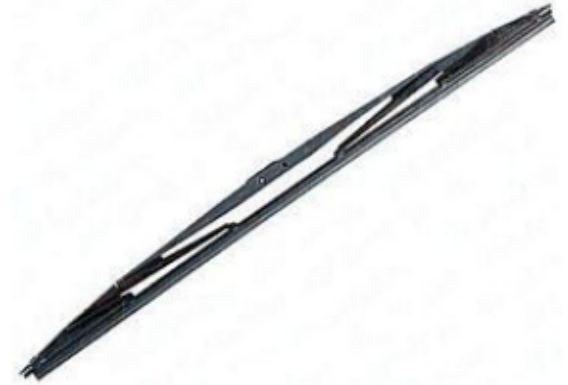
Windshield Wiper Blade

Wiper Blade Replacement - Front: Driver's side is loose, flopping over and marked glass.

If not replaced, worn out wiper blades can cause restricted visibility and permanent damage to the windshield.

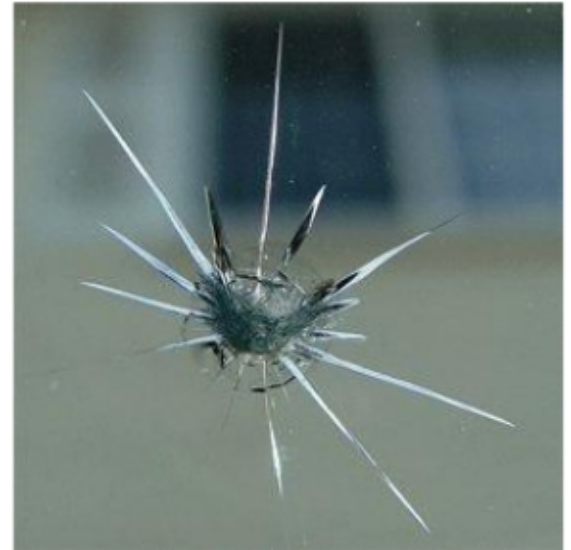
Windshield Chip Repair

Every rock chip will eventually crack out, and it is hard to determine how long any chip can hold until the damage is too large to repair, but if that little chip spreads, it will cost you a new windshield.

Windshield chip repair is a fast and convenient way to take care of the annoying but unavoidable rock chips.
