## Automobile Status Report

2018 Toyota COROLLA

**VIN** 2T1BURHE4JC115631

# Multi-Point Inspection Checklist

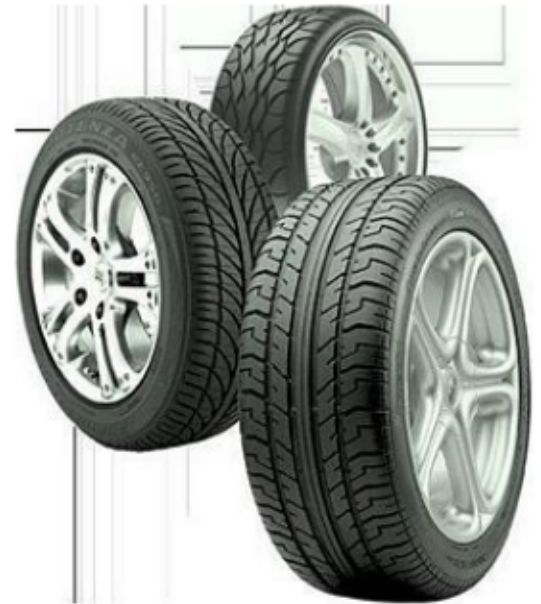
Tires

## \*Tires - 4: 215/45R17 - Front 3-4/32, Rear chopped, road noise.

According to most states' laws, tires are legally worn out when they have worn down to 2/32" of remaining tread depth. As a tire wears it's important to realize that the tire's ability to perform in rain and snow will be reduced. With 2/32" of remaining tread depth, resistance to hydroplaning in the rain at highway speeds has been significantly reduced, and traction in snow has been virtually eliminated. If rain and wet roads are a concern, you should consider replacing your tires when they reach approximately 4/32" of remaining tread depth.

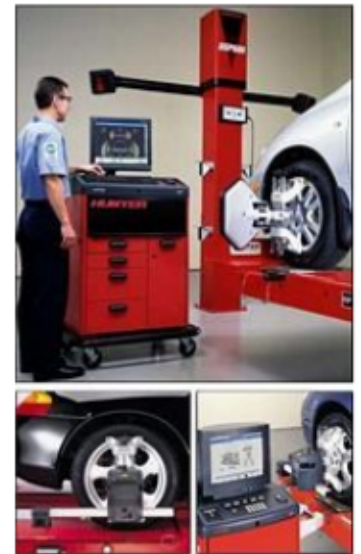
Alignment

## \*Alignment

If not done, you will see uneven or rapid tire wear, pulling or drifting away from a straight line, and wandering on a straight level road. It can also cause extra load on certain suspension components, making them more likely to fail.

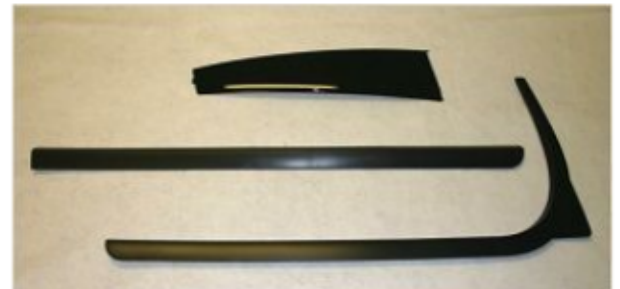
## \*Trim - Exterior: Right Rear Wheel Well Deflector (lower, front of wheel) and screw missing.

Trim can crack and even break off. Damaged trim often looks unappealing and can even create sharp surfaces.
