# Little Apple Cars

## Automobile Status Report

2023 Toyota COROLLA

# Multi-Point Inspection Checklist

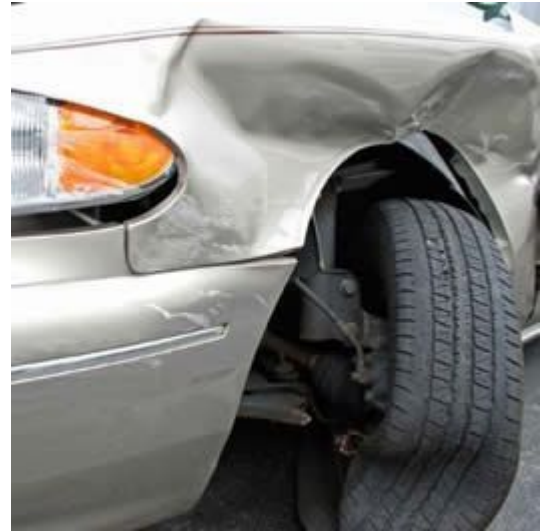
## Body Repair: Left license plate mounting nut is ripped out of panel.

Body repair is necessary to repair or replace areas of the vehicle that have dents, scratches, cracks or any other repairs that have been caused by an accident.

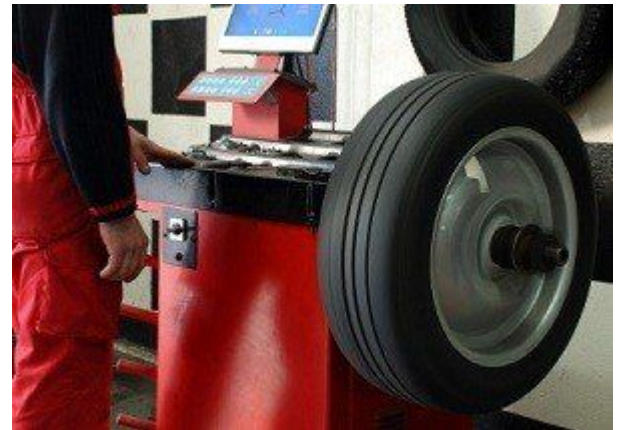
## \*Tire Balance and Rotate: Front 7/32, Rear 9/32

Balancing the vehicles tires are necessary to make sure the proper weight of the vehicle is distributed to the proper tire. Tire rotation helps protect tires against uneven wear by moving the tire location on the vehicle. Most tires will exhibit some form of wear based on numerous factors including: wheel alignment, miles driven, driving style and habits, and tire location on the vehicle. By moving or "rotating" the tires as recommended by the vehicle manufacturer, tires may wear more evenly; helping extend the life of the tires.
