Automobile Status Report

2020 Hyundai TUCSON

VIN KM8J3CA42LU103170

Multi-Point Inspection Checklist

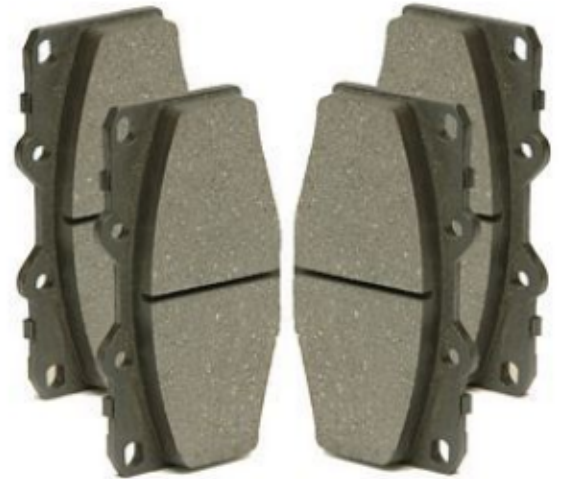
Brake Pads Replacement Only - Rear: Material showing 5mm

Brake pad material wears out over time. Brake pads should be periodically inspected for wear, which is highly variable depending on vehicle weight and driver habits. Brake pads must be replaced before the friction material is worn away completely. If it isn't, metal-to-metal contact will occur between the brake rotor and the worn-out brake pad. If metal-to-metal contact occurs, the brake rotor will be damaged, and it will need to be resurfaced or replaced.

SERVICE NAME					COST
Brake Pads Replacement Only - Rear: Material showing 5mm (I)					
LABOR	1.00 hours at \$165.00 per hour				\$165.00
PARTS	Qty	Description	Number	Price	Total
	1	REAR BRAKES (OR)	1032098	\$81.34	\$81.34
Parts and labor sub total					\$246.34
Lug and Wheel studs: need 4 lug nuts (I)					
LABOR	0.50 hours at \$165.00 per hour				\$82.50
PARTS	Qty	Description	Number	Price	Total
	4	LUG NUT (OR)	711305	\$10.35	\$41.40
Parts and labor sub total					\$123.90

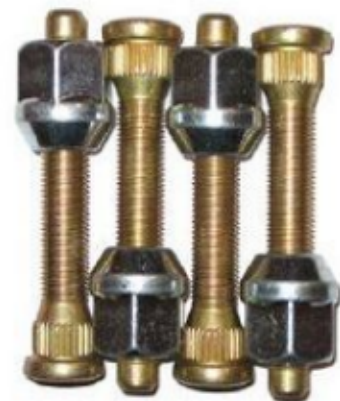
Lug and Wheel studs: need 4 lug nuts

If not replaced, this creates a serious hazard to the driver and passengers. Without the lug and wheel studs functioning properly, the wheel will not be properly secured to the vehicle. If not addressed,

eventually the wheel can separate, causing serious damage to the vehicle.
