Automobile Status Report

2021 Toyota SIENNA

VIN 5TDJSKFC4MS024459

Multi-Point Inspection Checklist

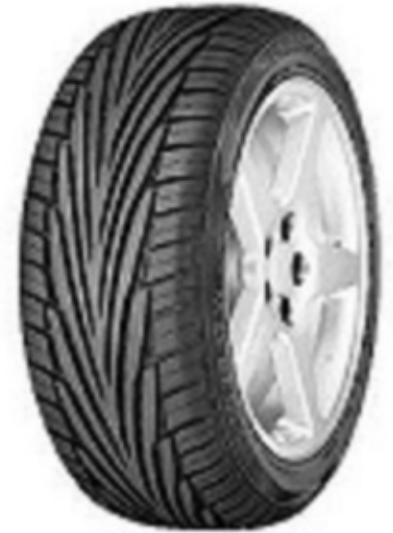
Tires

***Tires - 2: 235/65R17 Yokohama BluEarth S34 - LR not matching tire, RR 5/32. Front tires 6/32.**

According to most states' laws, tires are legally worn out when they have worn down to 2/32" of remaining tread depth. As a tire wears it's important to realize that the tire's ability to perform in rain and snow will be reduced. With 2/32" of remaining tread depth, resistance to hydroplaning in the rain at highway speeds has been significantly reduced, and traction in snow has been virtually eliminated. If rain and wet roads are a concern, you should consider replacing your tires when they reach approximately 4/32" of remaining tread depth.

If snow-covered roads are a concern, you should consider replacing your tires when they reach approximately 6/32" of remaining tread depth to maintain good mobility. Because tread depth is such an important element for snow traction, winter tires usually start with noticeably deeper tread depths than typical All-Season or summer tires. Some winter tires even have a second series of "wear bars" molded in their tread pattern indicating approximately 6/32" remaining tread

depth to warn you when your tires no longer meet the desired tread depth.

SERVICE NAME		COST			
*Tires - 2: 235/65R17 Yokohama BluEarth S34 - LR not matching tire, RR 5/32. Front tires 6/32. (I)					
LABOR	0.60 hours at \$137.50 per hour			\$82.50	
PARTS	Qty	Description	Number	Price	Total
	2	TIRE P235/65R17	42751YOK7381	\$196.96	\$393.92
				Parts and labor sub total	\$476.42
*Tire Balance and Rotate: Balance front tires and move to rear. New tires on front. (I)					
LABOR				\$49.95	
PARTS				\$0.00	
				Parts and labor sub total	\$49.95

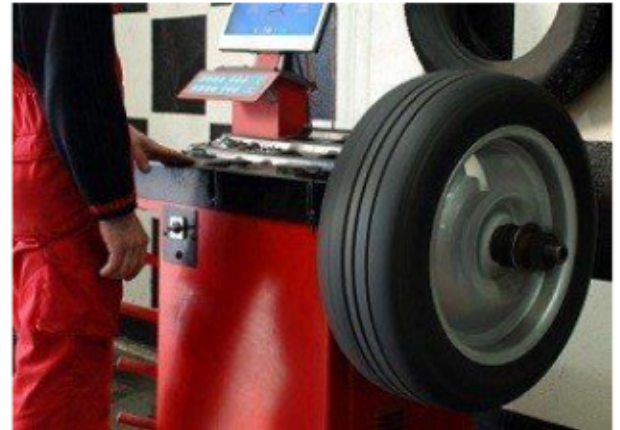
***Tire Balance and Rotate: Balance front tires and move to rear. New tires on front.**

If not properly balanced, a vehicle's tires can experience abnormal wear which can significantly decrease the life of the tire. If not done, you will experience vibration in the steering wheel at certain highway speeds. Also, vibration will occur in the seat or floorboard at certain highway speeds. Tire wear will become scalloped or cupped.

Balancing the vehicles tires are necessary to make sure the proper weight of the vehicle is distributed to the proper tire. Tire rotation helps protect tires against uneven wear by moving the tire location on the vehicle. Most tires will exhibit some form of wear based on numerous factors including: wheel alignment, miles driven, driving style and habits, and tire location on the vehicle. By moving or "rotating" the tires as recommended by the vehicle manufacturer, tires may wear more evenly; helping extend the life of the tires.
