Automobile Status Report

2018 Jeep GRAND CHEROKEE

VIN 1C4RJFBG8JC179003

Multi-Point Inspection Checklist

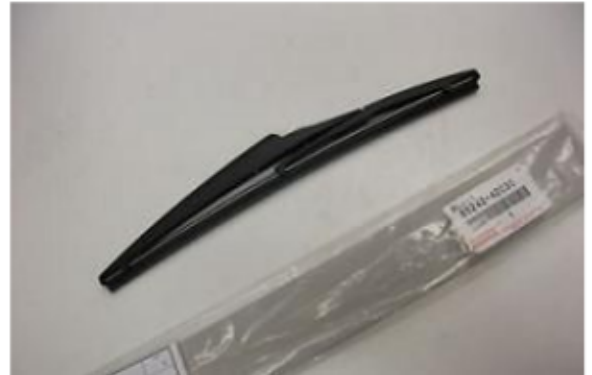
Wiper Blade Replacement - Rear: Incomplete contact with glass - start with new blade (not an insert). May need wiper arm.

The rear windshield wiper will need to be replaced occasionally. When you notice the wiper streaking on the glass or becoming worn, remove it immediately and have it properly replaced.
