Automobile Status Report

2015 Honda PILOT

VIN 5FNYP3H41FB018740

Multi-Point Inspection Checklist

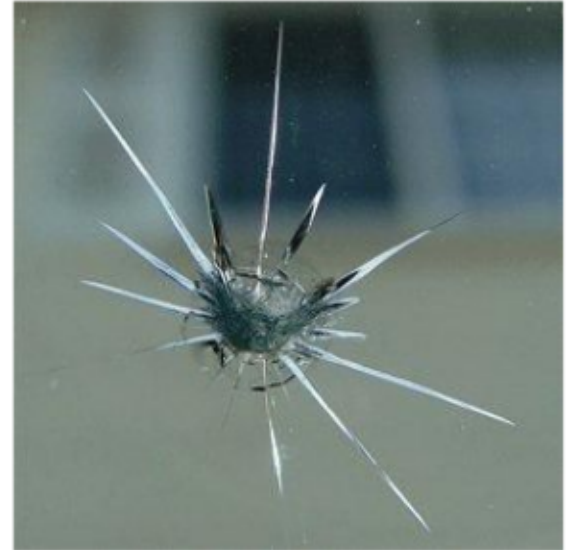
Windshield Chip Repair: Two on driver's side.

Every rock chip will eventually crack out, and it is hard to determine how long any chip can hold until the damage is too large to repair, but if that little chip spreads, it will cost you a new windshield.

Windshield chip repair is a fast and convenient way to take care of the annoying but unavoidable rock chips.

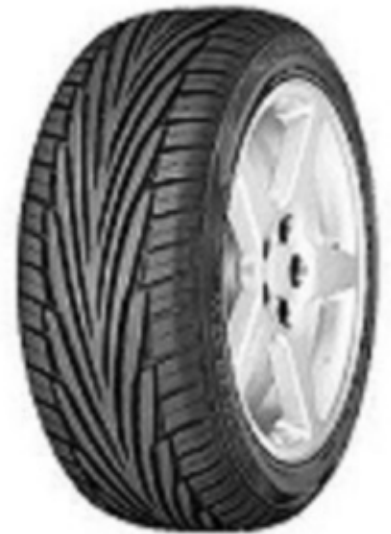
Tires

*Tires - 2: 235/60R18 - Rear tires 3/32

According to most states' laws, tires are legally worn out when they have worn down to 2/32" of remaining tread depth. As a tire wears it's important to realize that the tire's ability to perform in rain and snow will be reduced. With 2/32" of remaining tread depth, resistance to hydroplaning in the rain at highway speeds has been significantly reduced, and traction in snow has been virtually eliminated. If rain and wet roads are a concern, you should consider replacing your tires when they

reach approximately 4/32" of remaining tread depth.

If snow-covered roads are a concern, you should consider replacing your tires when they reach approximately 6/32" of remaining tread depth to maintain good mobility. Because tread depth is such an important element for snow traction, winter tires usually start with noticeably deeper tread depths than typical All-Season or summer tires. Some winter tires even have a second series of "wear bars" molded in their tread pattern indicating approximately 6/32" remaining tread depth to warn you when your tires no longer meet the desired tread depth.

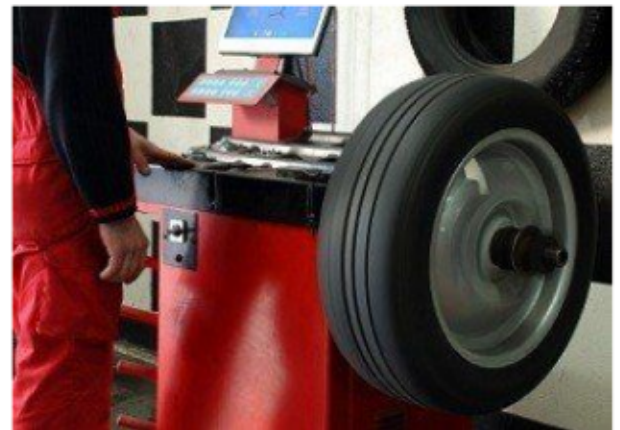
If not properly balanced, a vehicle's tires can experience abnormal wear which can significantly decrease the life of the tire. If not done, you will experience vibration in the steering wheel at certain highway speeds. Also, vibration will occur in the seat or floorboard at certain highway speeds. Tire wear will become scalloped or cupped.

***Tire Balance and Rotate: Balance front tires and move to rear. Place new tires on front.**
